**Flood Control Project Maintenance  
Levee Inspections**

**Fall 2012 Levee Maintenance Deficiency Summary Report**

***San Joaquin River Basin***

**Reclamation District No. 0404 Boggs**

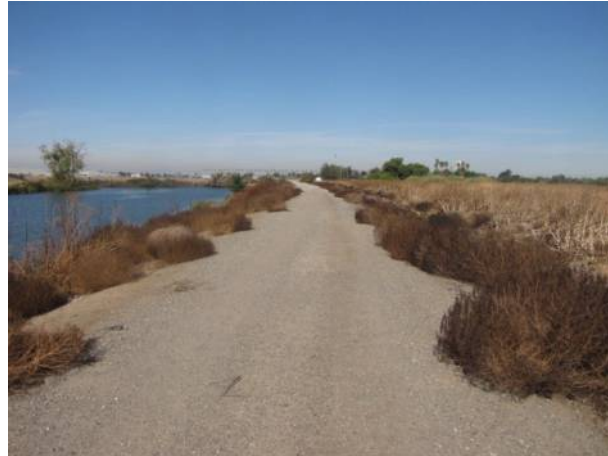
Levee Mile Report Line	4
Start Levee Mile	0.03
End Levee Mile	0.48
Location	Land Side
Category	Earthen Levee
Item	Vegetation
Looking north at modest vegetation on landside and waterside slopes.	
jhirabay_f_20121001_016.jpg

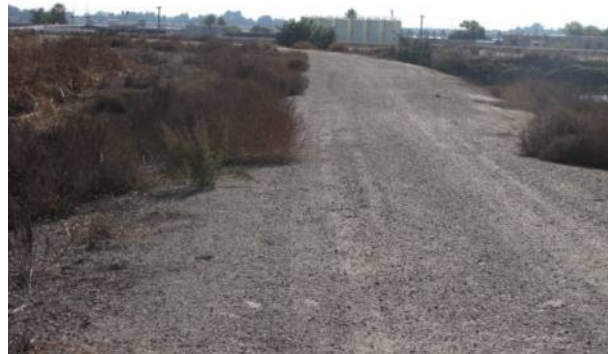
Levee Mile Report Line	5
Start Levee Mile	0.03
End Levee Mile	0.20
Location	Water Side
Category	Earthen Levee
Item	Vegetation
Looking south modest vegetation on waterside slope.	
jhirabay_f_20121001_020.jpg

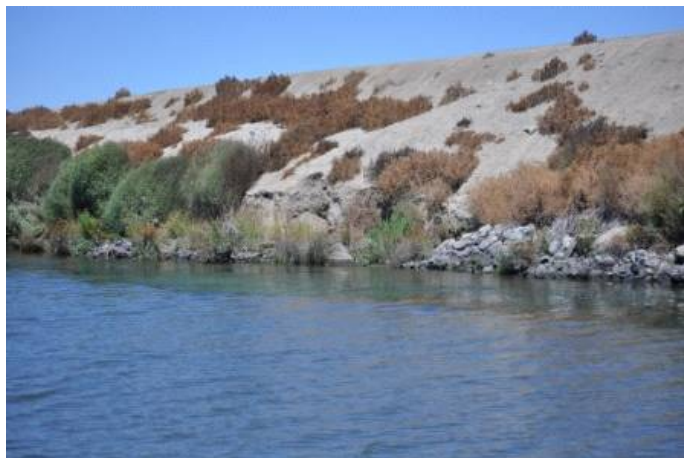
DWR ID: DWR_RD0404_01_s_2012_8										
6	0.21	0.26	Supplemental	DWR Erosion Survey	WS	U Ma	Inspector Comments: 08/07/2012: The site has been visited by boat survey. The erosion has developed in size, and more pocket erosion found. 8/23/2011: Pockets erosions observed by last survey seem have progressed during the last food season. Continuous monitoring of this site suggested 9/07/2010: No significant change observed on site. There is emergent vegetation at the water line. Several pocket erosions lined along the lower slope that stretches from RM 40.86 to RM 41.14. 9/30/2009: No major change observed; the site was combined with other existing sites are RM's 40.93, 40.98, and 41.14 as one site; several pocket erosion just above non-uniform toe rip rap; previously rated "U"; bare spots along the upper slope. 2008: Possibly caused by wave wash erosion; several pocket erosion along the lower slope; site is inside of a bend. 2006: Visited site 09/12/06. [2012 Site ID:RD0404U01RM40.86]	37.939480 ° -121.342730 °	37.939480 ° -121.342730 °	1 Y

Levee Mile Report Line	6
Start Levee Mile	0.21
End Levee Mile	0.26
Location	Water Side
Category	Supplemental
Item	DWR Erosion Survey
Downstream view of Site. Progressing pocket erosion visible.	
SJR2012_RD0404U01RM40.86_1.jpg

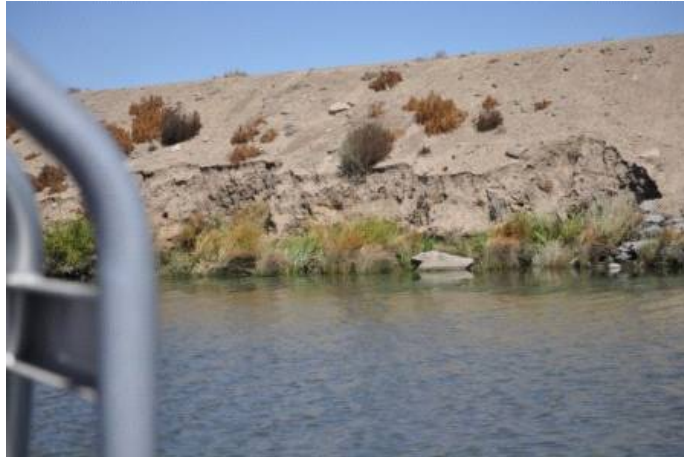
Levee Mile Report Line	6
Start Levee Mile	0.21
End Levee Mile	0.26
Location	Water Side
Category	Supplemental
Item	DWR Erosion Survey

Front view of the site

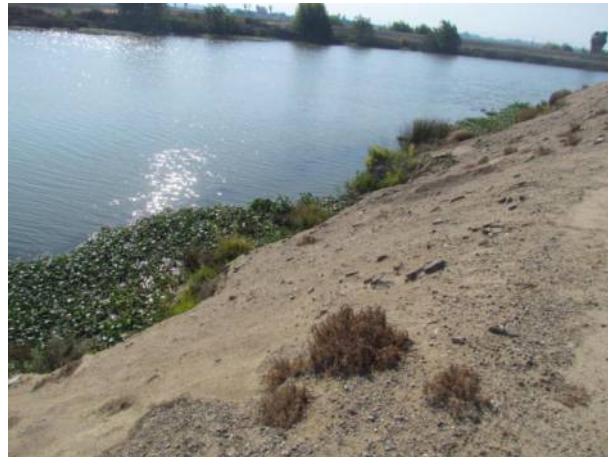
Levee Mile Report Line	7
Start Levee Mile	0.30
End Levee Mile	0.30
Location	Water Side
Category	Earthen Levee
Item	Erosion / Bank Caving

Looking northwest at toe erosion on waterside.

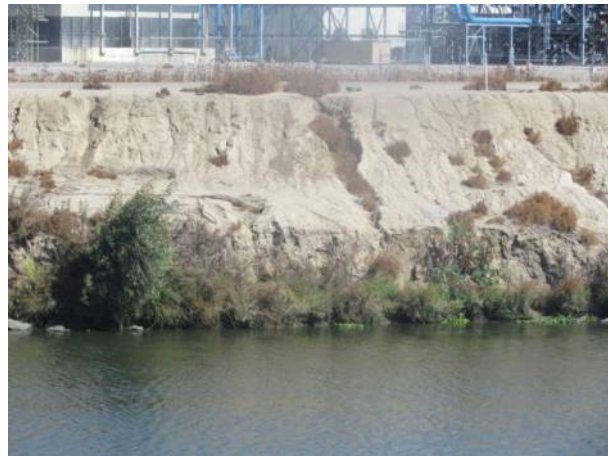
Levee Mile Report Line	7
Start Levee Mile	0.30
End Levee Mile	0.30
Location	Water Side
Category	Earthen Levee
Item	Erosion / Bank Caving

Looking east at erosion on slope and toe of levee.

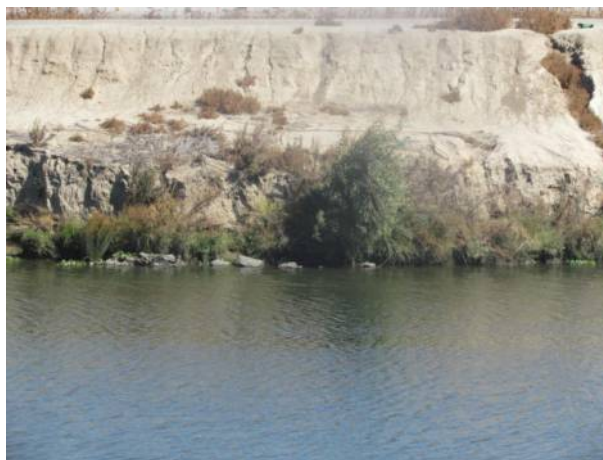
Levee Mile Report Line	7
Start Levee Mile	0.30
End Levee Mile	0.30
Location	Water Side
Category	Earthen Levee
Item	Erosion / Bank Caving

Looking east from RD 524 at erosion on slope and toe of levee.

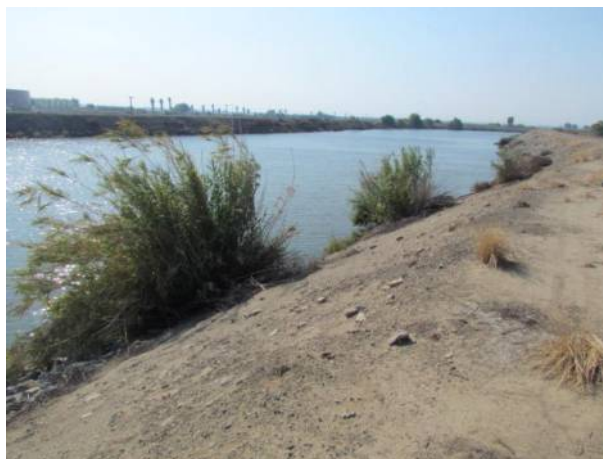
Levee Mile Report Line	8
Start Levee Mile	0.45
End Levee Mile	0.45
Location	Water Side
Category	Earthen Levee
Item	Vegetation

Looking northwest at bamboo on waterside toe.

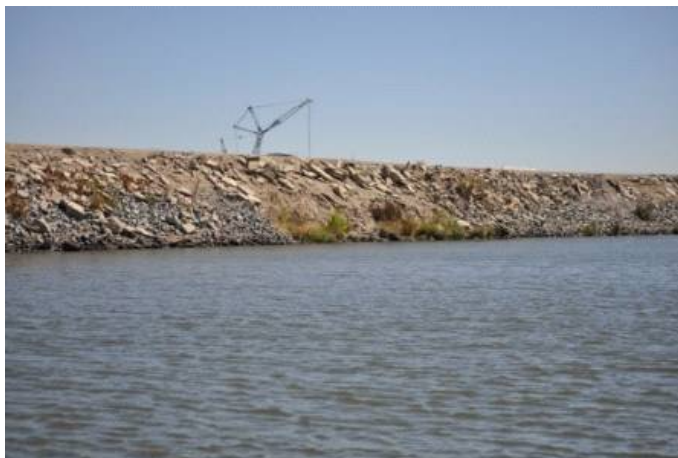
Levee Mile Report Line	9
Start Levee Mile	0.48
End Levee Mile	0.48
Location	Water Side
Category	Supplemental
Item	DWR Erosion Survey

Downstream view of the site.

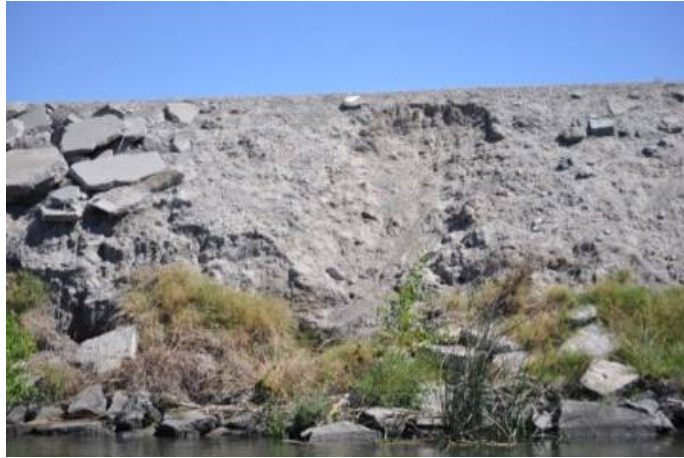
Levee Mile Report Line	10
Start Levee Mile	0.60
End Levee Mile	0.62
Location	Water Side
Category	Supplemental
Item	DWR Erosion Survey

Front view of the erosion. Note the slumping erosion at upper slope.

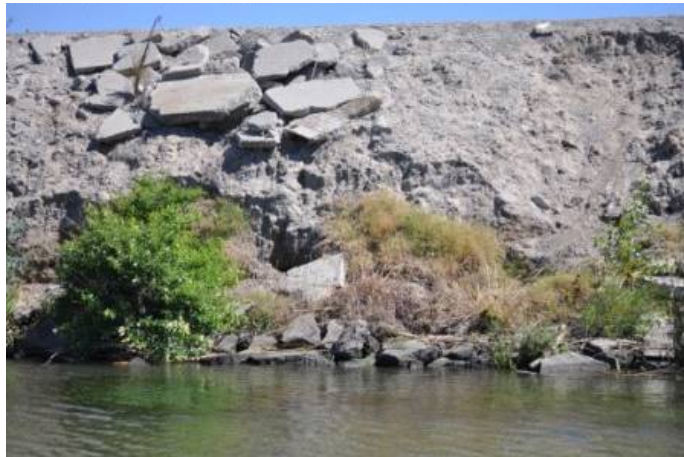
Levee Mile Report Line	10
Start Levee Mile	0.60
End Levee Mile	0.62
Location	Water Side
Category	Supplemental
Item	DWR Erosion Survey

Close view of erosion

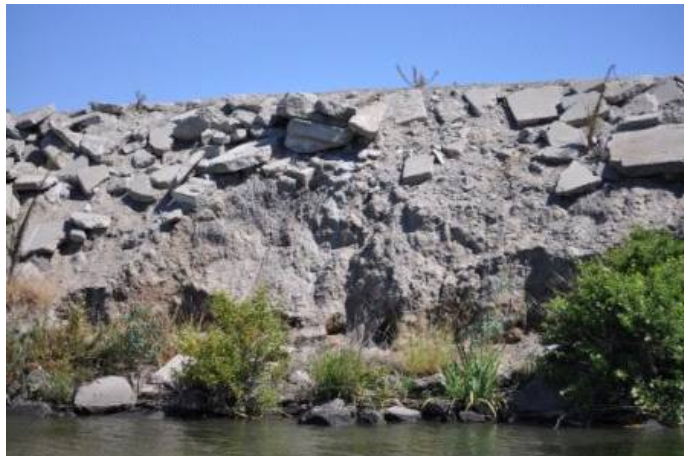
Levee Mile Report Line	10
Start Levee Mile	0.60
End Levee Mile	0.62
Location	Water Side
Category	Supplemental
Item	DWR Erosion Survey

Front view of erosion. Note the broken concrete blocks at the slope.

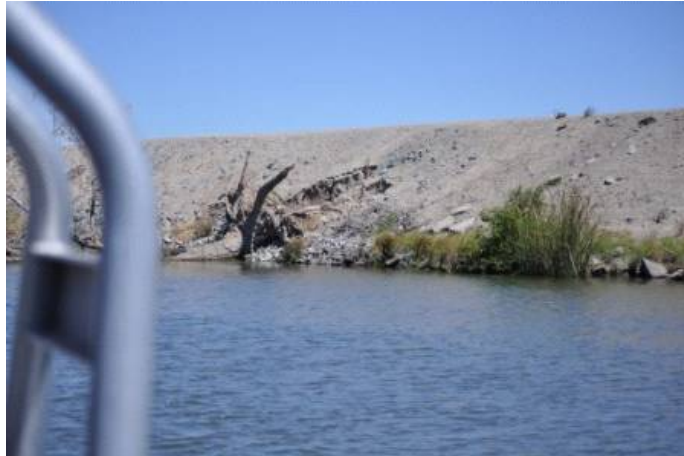
Upstream view of the site

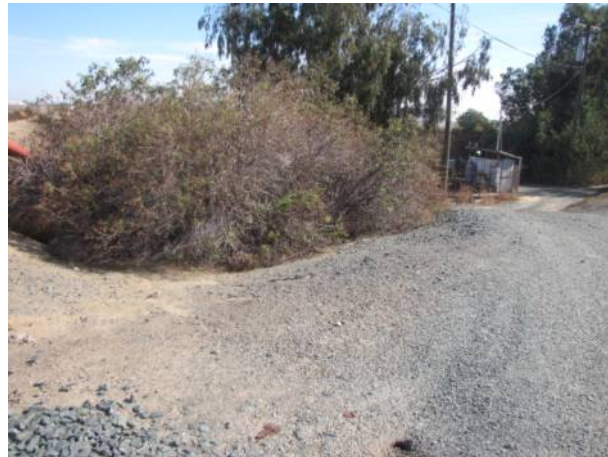
Levee Mile Report Line	13
Start Levee Mile	0.75
End Levee Mile	0.75
Location	Land Side
Category	Earthen Levee
Item	Vegetation

Looking southeast at elderberry on landside slope.

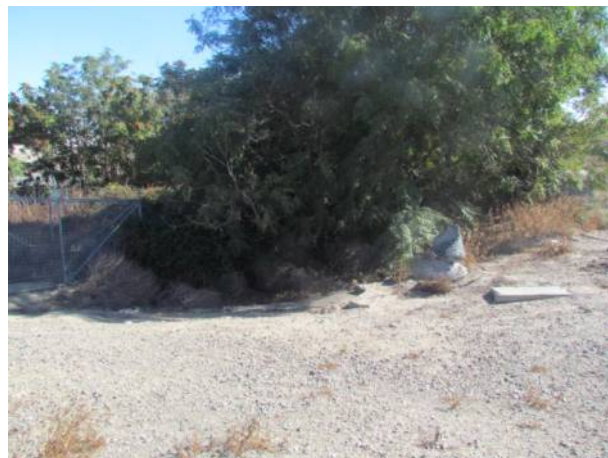
Levee Mile Report Line	17
Start Levee Mile	1.20
End Levee Mile	1.20
Location	Land Side
Category	Earthen Levee
Item	Vegetation

Looking southeast at overhanging trees on landside slope.

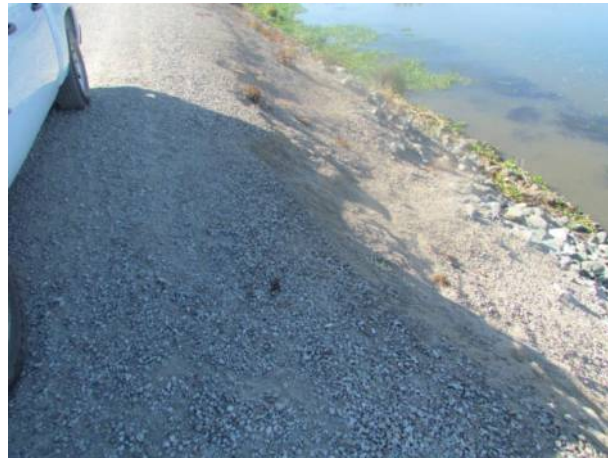
Looking northwest at slope damage on waterside slope.

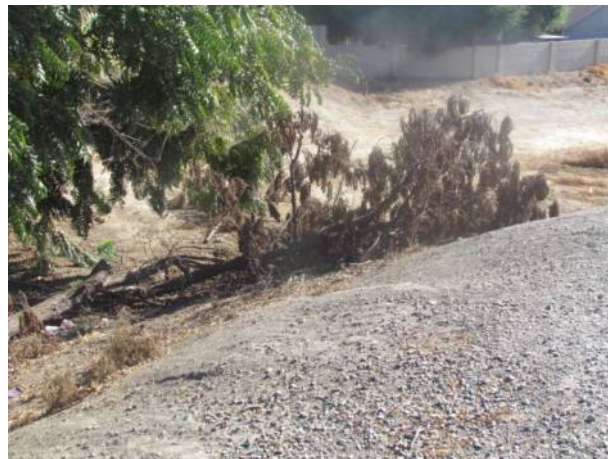
Levee Mile Report Line	21
Start Levee Mile	1.58
End Levee Mile	1.58
Location	Land Side
Category	Earthen Levee
Item	Encroachments

Looking east at tree limb on landside slope.

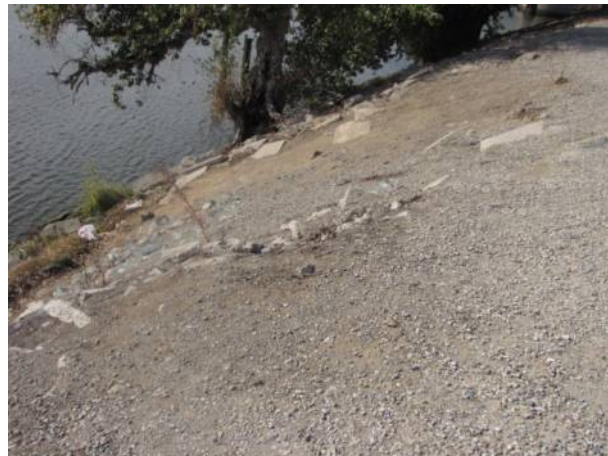
Levee Mile Report Line	22
Start Levee Mile	1.63
End Levee Mile	1.63
Location	Water Side
Category	Earthen Levee
Item	Slope Stability

Looking southwest at minor slope sliding on waterside slope.

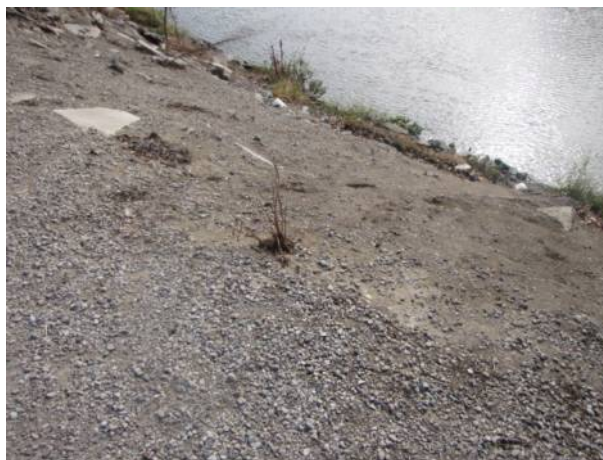
Looking southeast at minor slope sliding on waterside slope.

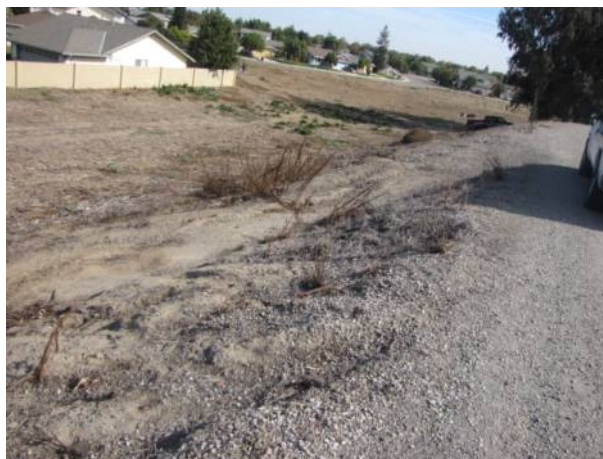
Levee Mile Report Line	23
Start Levee Mile	1.64
End Levee Mile	1.65
Location	Land Side
Category	Earthen Levee
Item	Slope Stability

Looking northeast at minor slope damage on landside slope cause by vehicle traffic.

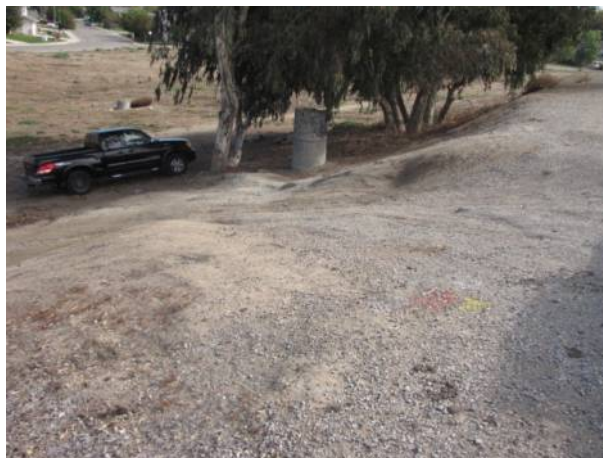
Levee Mile Report Line	23
Start Levee Mile	1.64
End Levee Mile	1.65
Location	Land Side
Category	Earthen Levee
Item	Slope Stability

Looking northeast at slope damage on landside slope cause by vehicle traffic.

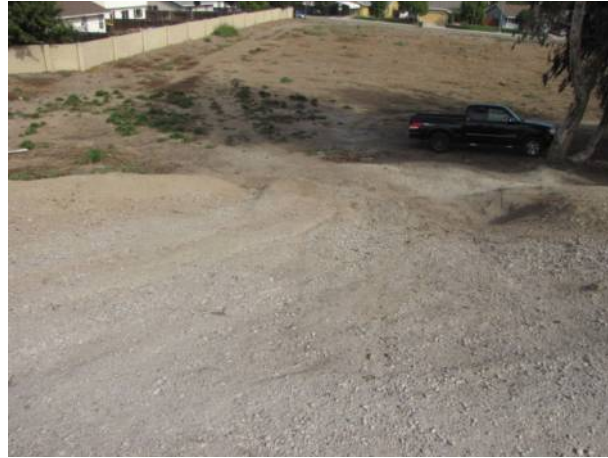
Looking east at slope damage on landside slope.

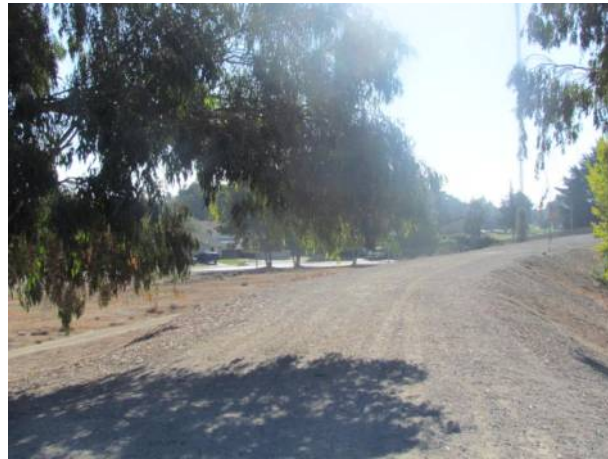
Levee Mile Report Line	24
Start Levee Mile	1.67
End Levee Mile	1.67
Location	Land Side
Category	Earthen Levee
Item	Trim / Thin Trees

Looking east at tree on landside overhanging levee crown.

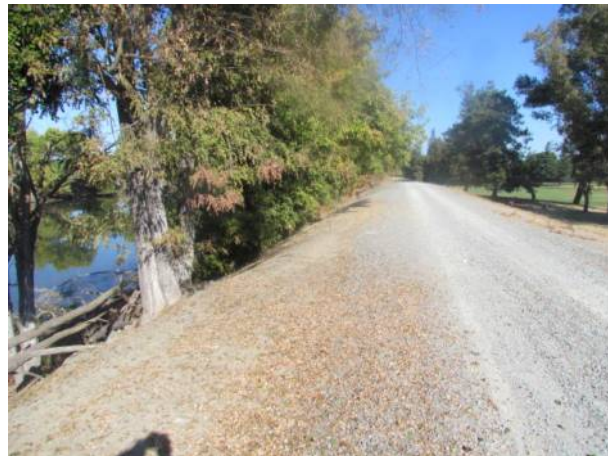
Levee Mile Report Line	25
Start Levee Mile	1.98
End Levee Mile	1.98
Location	Water Side
Category	Earthen Levee
Item	Trim / Thin Trees

Looking southwest at dense trees on waterside slope.

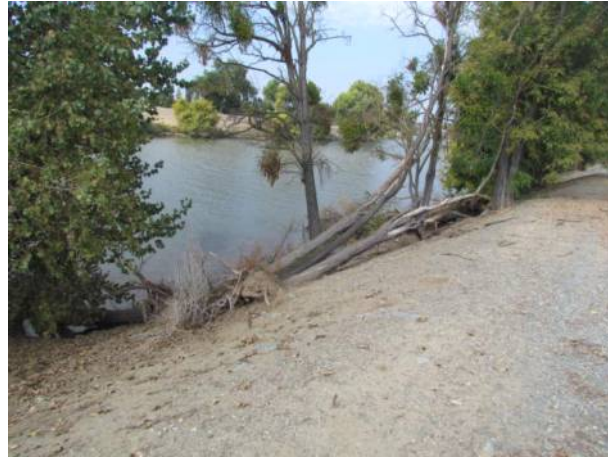
Looking northwest at downed tree on waterside slope.

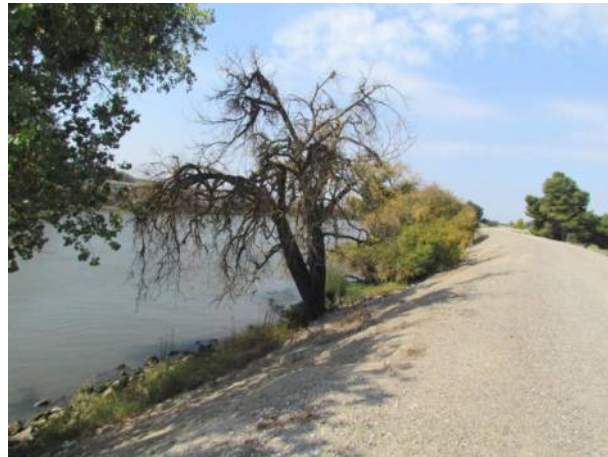
Levee Mile Report Line	28
Start Levee Mile	2.33
End Levee Mile	2.33
Location	Water Side
Category	Earthen Levee
Item	Trim / Thin Trees

Looking northeast at dead tree on waterside toe.

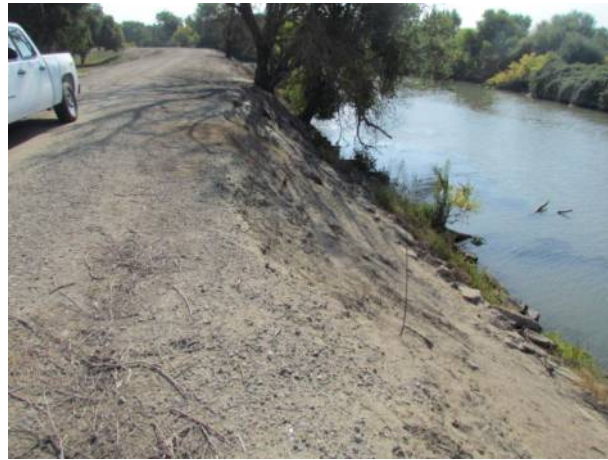
Looking west at waterside slope erosion.

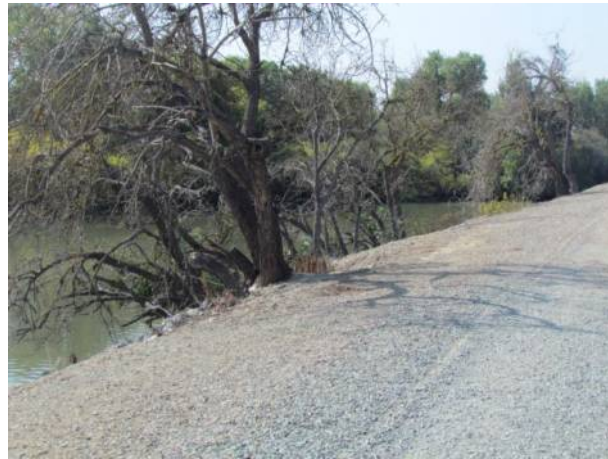
Levee Mile Report Line	3
Start Levee Mile	0.12
End Levee Mile	0.15
Location	Water Side
Category	Earthen Levee
Item	Trim / Thin Trees

Looking northwest at dead trees on waterside slope.

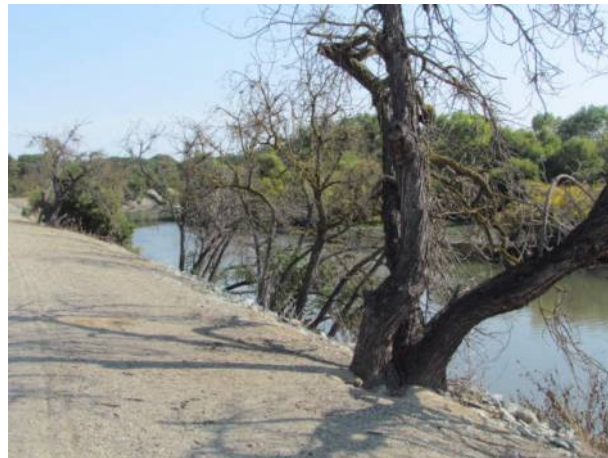
Levee Mile Report Line	3
Start Levee Mile	0.12
End Levee Mile	0.15
Location	Water Side
Category	Earthen Levee
Item	Trim / Thin Trees

Looking southwest at dead trees on waterside slope.

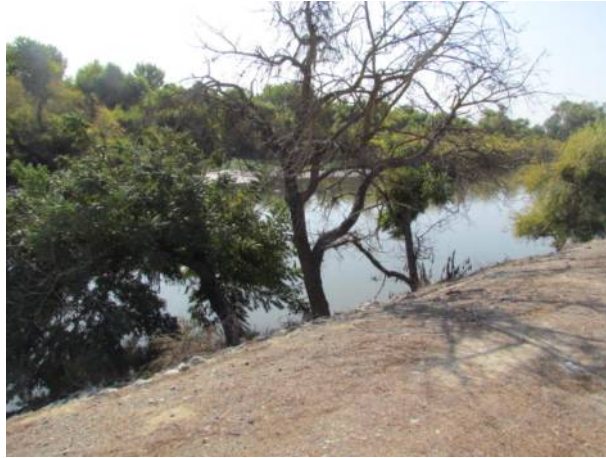
Looking east at dead tree on waterside slope.

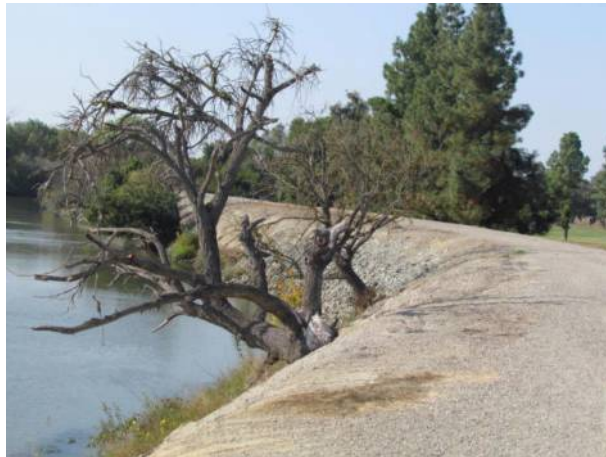
Levee Mile Report Line	7
Start Levee Mile	0.36
End Levee Mile	0.36
Location	Water Side
Category	Earthen Levee
Item	Trim / Thin Trees

Looking northwest at dead tree on waterside slope.

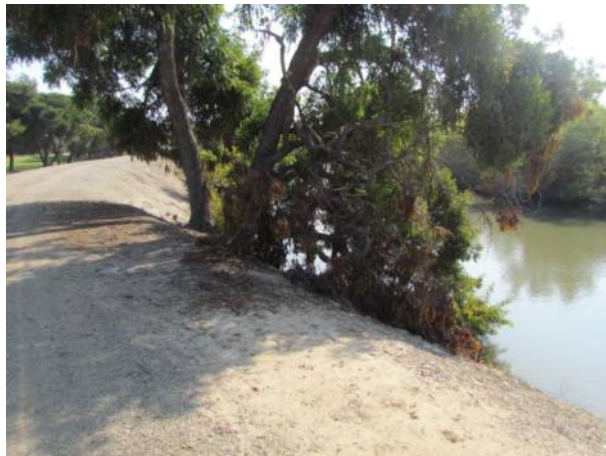
Levee Mile Report Line	10
Start Levee Mile	0.48
End Levee Mile	0.48
Location	Water Side
Category	Earthen Levee
Item	Encroachments

Looking southeast at downed tree limb on waterside slope.

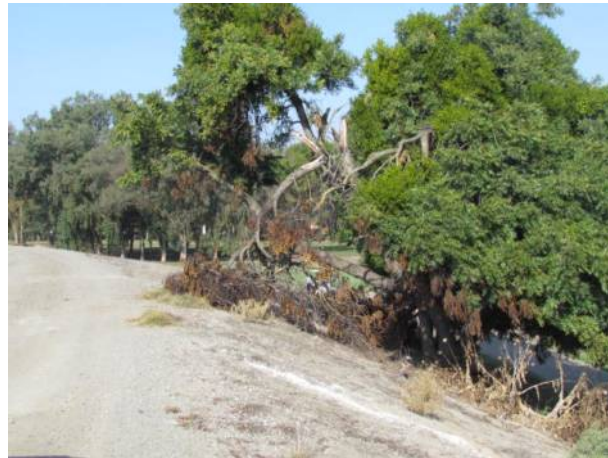
Looking northwest at downed tree limbs on landside slope.

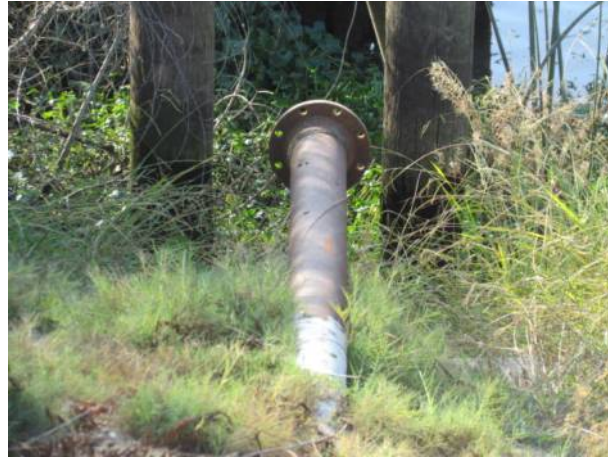
Looking south at 4-6" pipe on waterside slope.

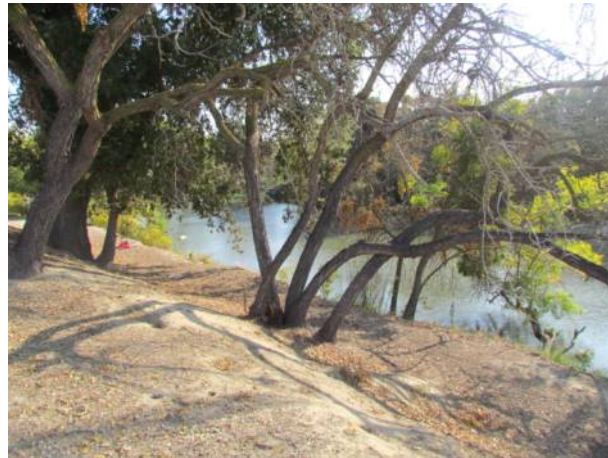
Looking southwest at several dead trees on waterside slope.

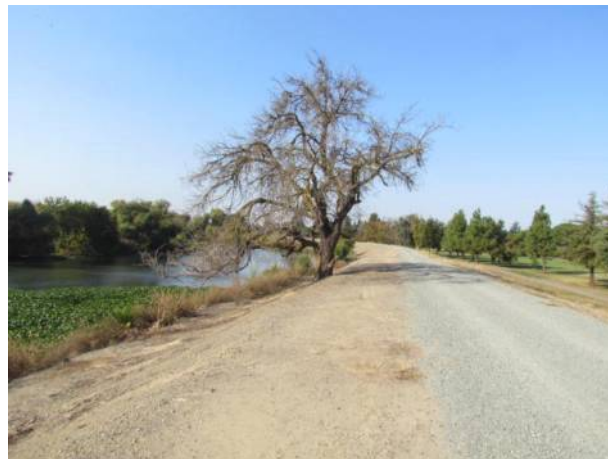
Levee Mile Report Line	25
Start Levee Mile	1.44
End Levee Mile	1.44
Location	Water Side
Category	Earthen Levee
Item	Trim / Thin Trees

Looking east at dead tree on waterside slope.

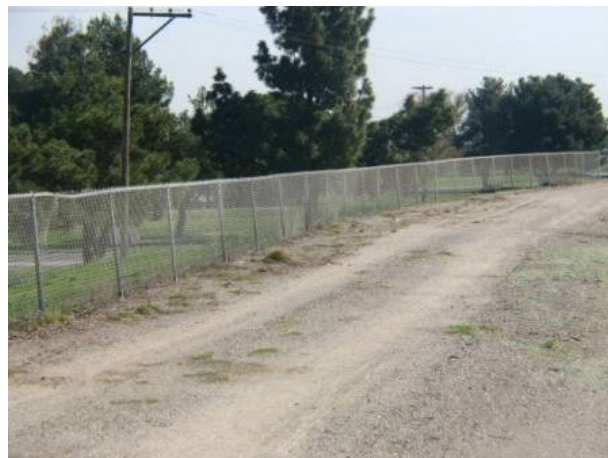
Levee Mile Report Line	26
Start Levee Mile	1.47
End Levee Mile	1.52
Location	Land Side
Category	Earthen Levee
Item	Encroachments

Fence at landside shoulder from LM 1.47 to 1.52

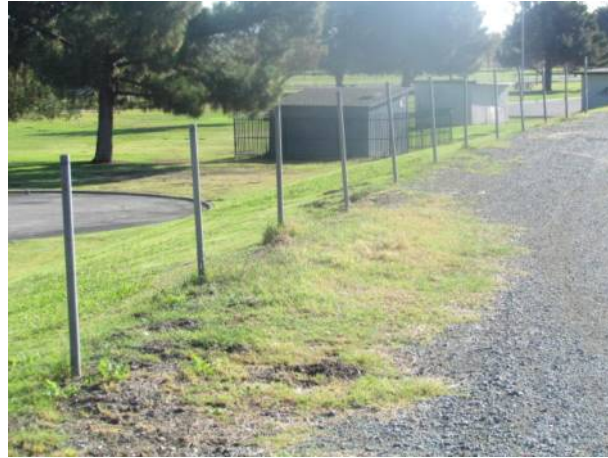
Looking northeast at fence poles on landside shoulder.

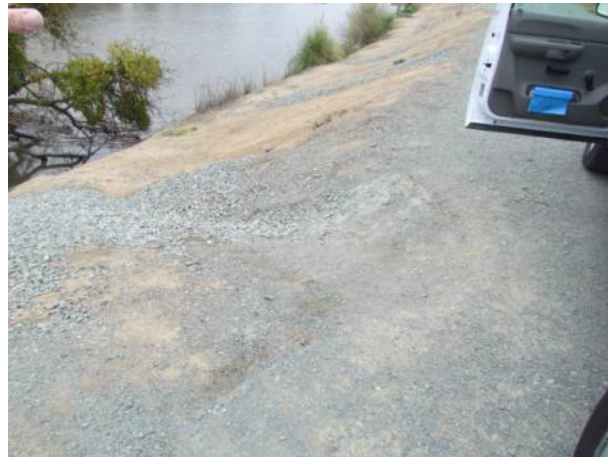
Levee Mile Report Line	27
Start Levee Mile	1.47
End Levee Mile	1.53
Location	Water Side
Category	Earthen Levee
Item	Slope Stability

Looking south at one of several foot traffic erosion on waterside slope.

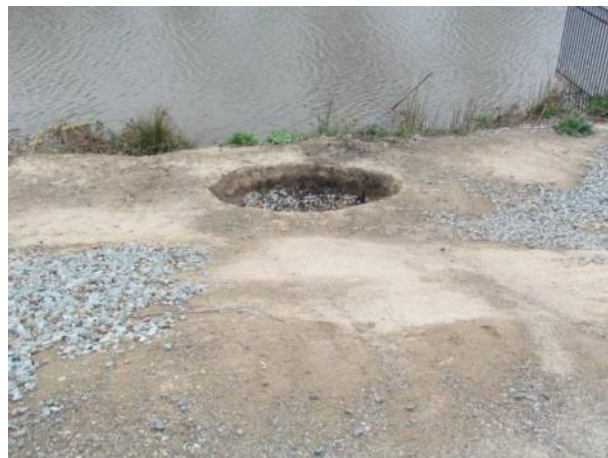
Levee Mile Report Line	28
Start Levee Mile	1.47
End Levee Mile	1.47
Location	Water Side
Category	Earthen Levee
Item	Erosion / Bank Caving

Looking south at possible sink hole on waterside berm.

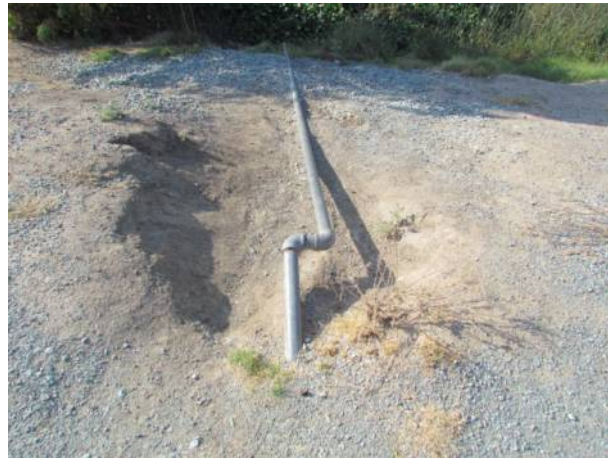
Looking south at 3" pipe on waterside slope.

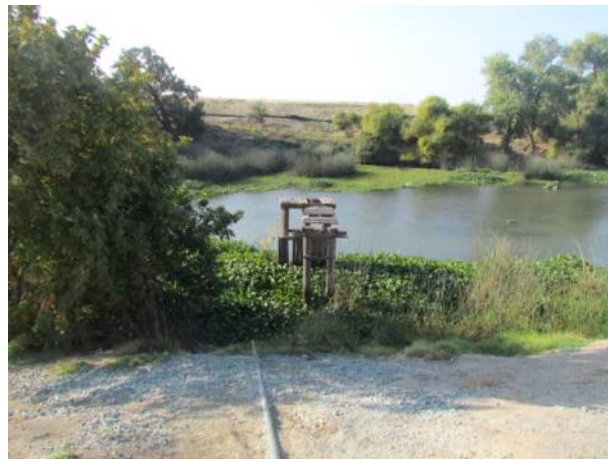
Levee Mile Report Line	31
Start Levee Mile	1.55
End Levee Mile	1.55
Location	Water Side
Category	Earthen Levee
Item	Encroachments

LMR No.	Levee Mile		Category	Item	Location *	Rating ** + Ma	Action/Comment	GPS Latitude/Longitude		Issue No. Photo
	Start	End						Start	End	
31	1.55	1.55	Earthen Levee	Encroachments	WS	U	EQ : Equipment Inspector Comments: Abandoned pump stand in channel should be removed and 3" galvanized pipe on waterside slope. Pipe was dug out by unknown person. Left major trench (hole) on waterside slope. Trench (hole) should be replaced before flood season.	37.918397 ° -121.295110 °	37.918397 ° -121.295110 °	60 Y
DWR ID: DWR_RD0404_02_s_2012_60										
32	1.76	1.76	Earthen Levee	Trim / Thin Trees	WS	M	T1 : Trim trees to at least five feet above ground level.	37.917302 ° -121.291778 °	37.917302 ° -121.291778 °	59 Y
DWR ID: DWR_RD0404_02_s_2012_59

Looking southwest at wooden pump stand in channel.

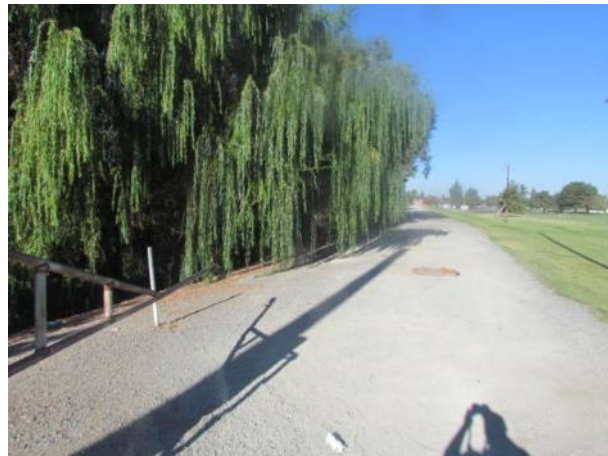
Levee Mile Report Line	32
Start Levee Mile	1.76
End Levee Mile	1.76
Location	Water Side
Category	Earthen Levee
Item	Trim / Thin Trees

Looking west at overhanging tree on waterside slope.
